## DELAWARE CITY BRIDGE

4. TITLE (and Subtitle) Bridge inspection report no. 11C, Delaware City Bridge, Delaware		5. TYPE OF REPORT & PERIOD COVERED Bridge inspection report no. 11C; Contract report 1979

6  
**BRIDGE INSPECTION  
REPORT NO. 11 C.**

**DELAWARE CITY BRIDGE,**

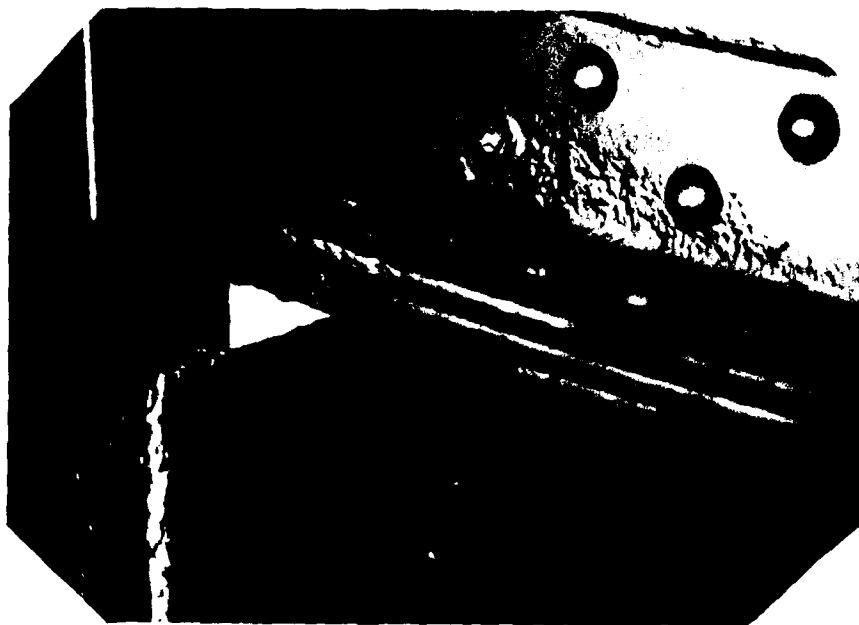
Inspection revealed corrosion of metal work at juncture of trunnion bearing and shaft (See photographs 1-7 and 1-8). The surfaces of bottom flanges of the main girders show signs of rust (See photograph 1-9). This is due to debris collected on the flanges. This can be avoided by installing a drip plate on the bottom flange in line with outside face of the piers. Paint on metal work in general appeared in good condition.

Photograph 1-9 - Rusted bottom flange, east of west girder, inside north pier.

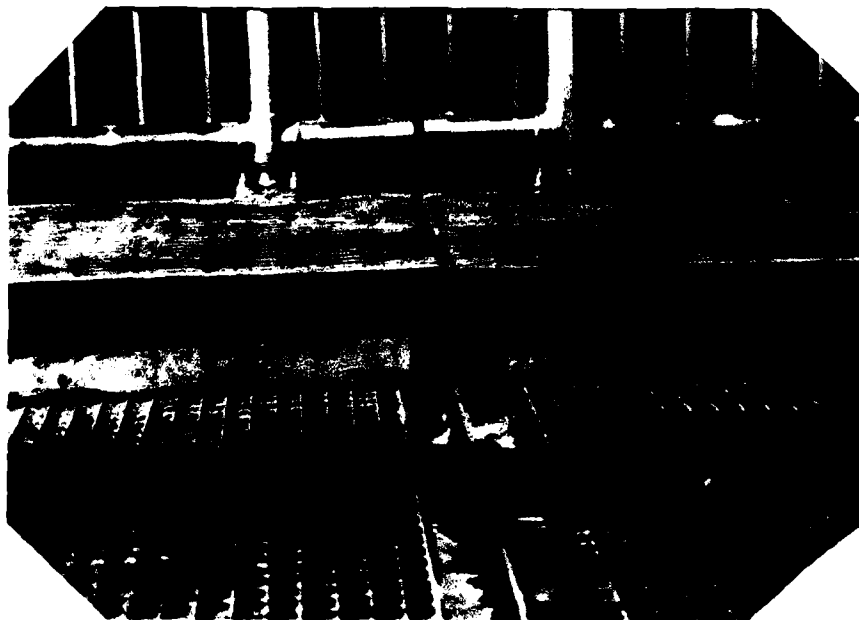
Photograph 1-14 - Joint opening at mid-span,  
west sidewalk.

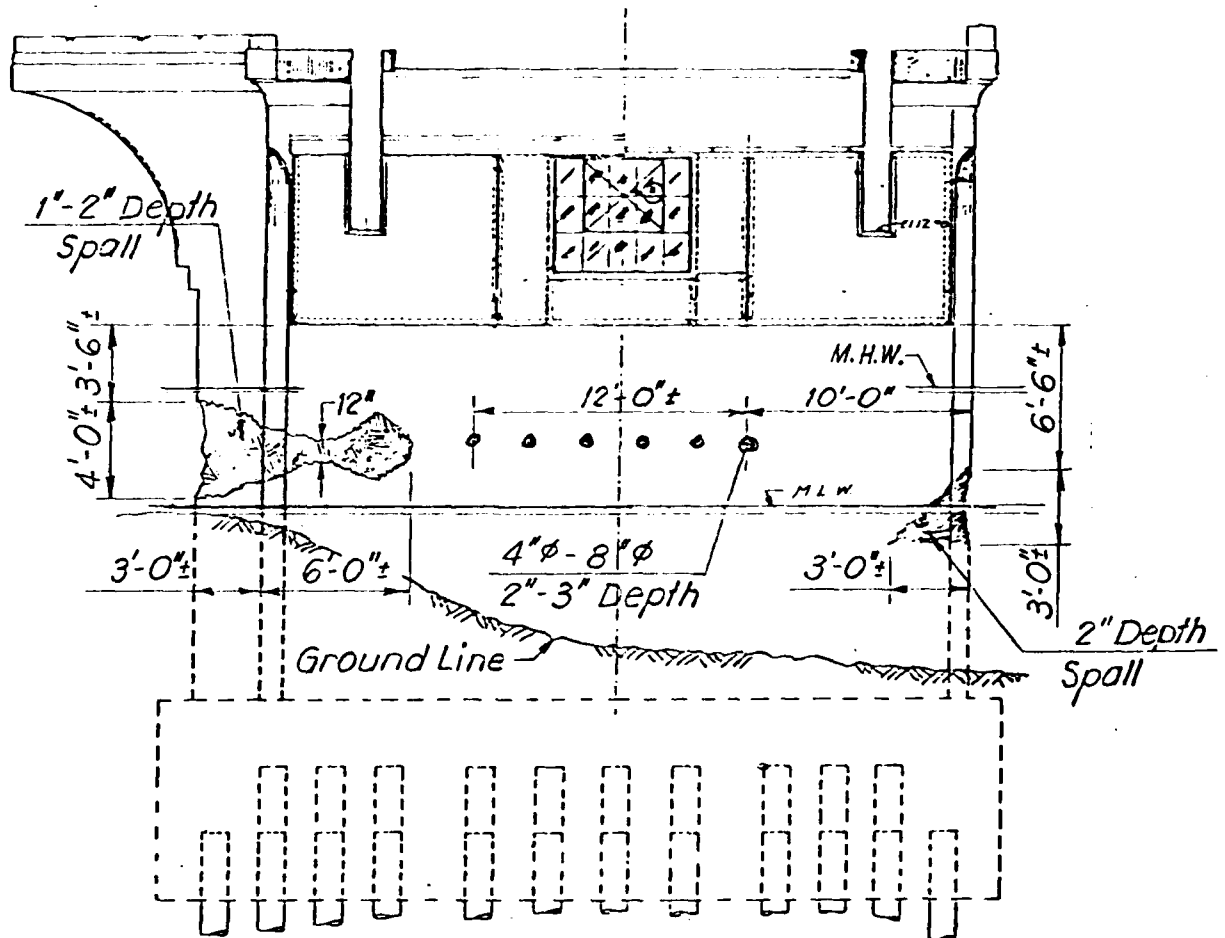
DRAWING 1-3

1. Piers: There is no evidence of settlement or shifting of piers. Outside concrete surface at piers has spalls as shown in drawings 1-3 and 1-4. The inside concrete surface at north pier has spalls in the roof slab (See photograph 1-3). The concrete wall (well area) at west side of the north pier has a crack about 4' below top slab that runs horizontally (See photograph 1-4). The large chamber inside the pier (previously used to accommodate the counterweight) at the south pier had about 4' deep water and at the north pier about 2' deep water. This condition indicates possibility of cracks below channel water level. Access to the north pier chamber, was obtained through the abandoned operator's house at west side of bridge and to the south pier chamber through a manhole in the east sidewalk. The door in the operator's house and manhole cover are welded shut, the doors in pier channel faces are also closed, therefore preventing transients and children from gaining access to the pier chambers. Inside and outside trunnion columns are in good condition except for corrosion at lower half of the inside column. Most of the anchor bolts are rusted. The inside trunnion column support flanges

An underwater inspection of the piers was included in this inspection. Visual inspection at low water line and probing below water to the mud line revealed the need for subsurface repair (See Drawings 1-3 and 1-4).

- \* 1. Repair broken welds at open grid deck.
- \* 2. Spot paint following structural members:
  - a. Stringers and bracings
  - b. Floorbeams
  - c. Main girders
- \* 3. Paint inside trunnion columns including the bases at both piers.
- \* 4. Paint existing unused holes of stringers.
- \* 5. Repair broken welds in bridge railing, replace southwest end-post of railing and paint the rusted area.
- 6. Repair spalls in concrete at inside and outside surfaces of piers.
- \* 7. Repair east concrete sidewalk at mid-span.

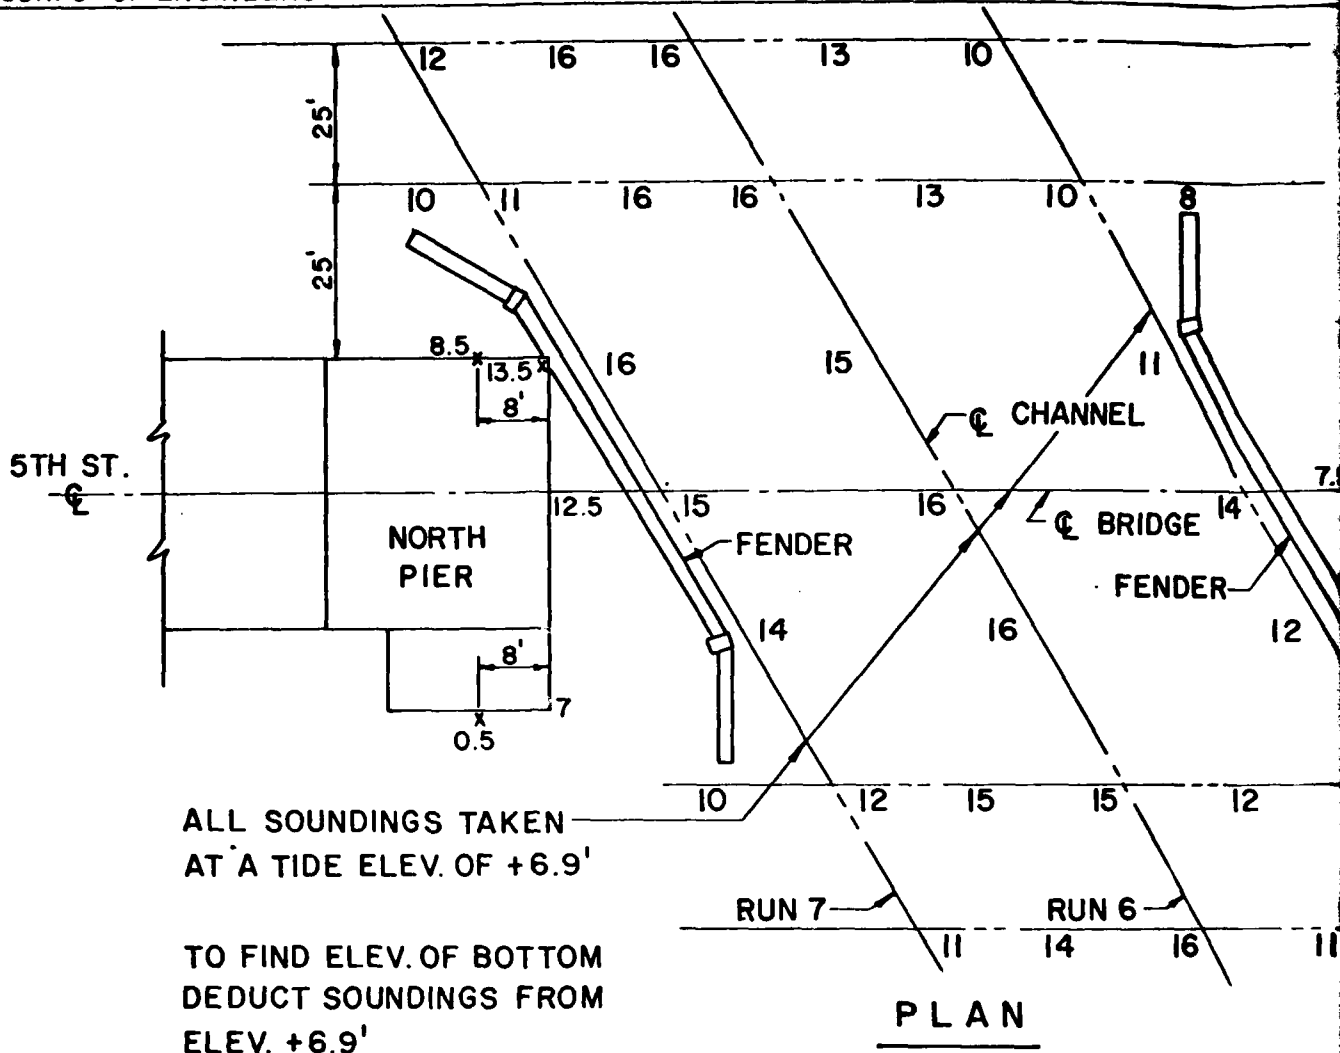
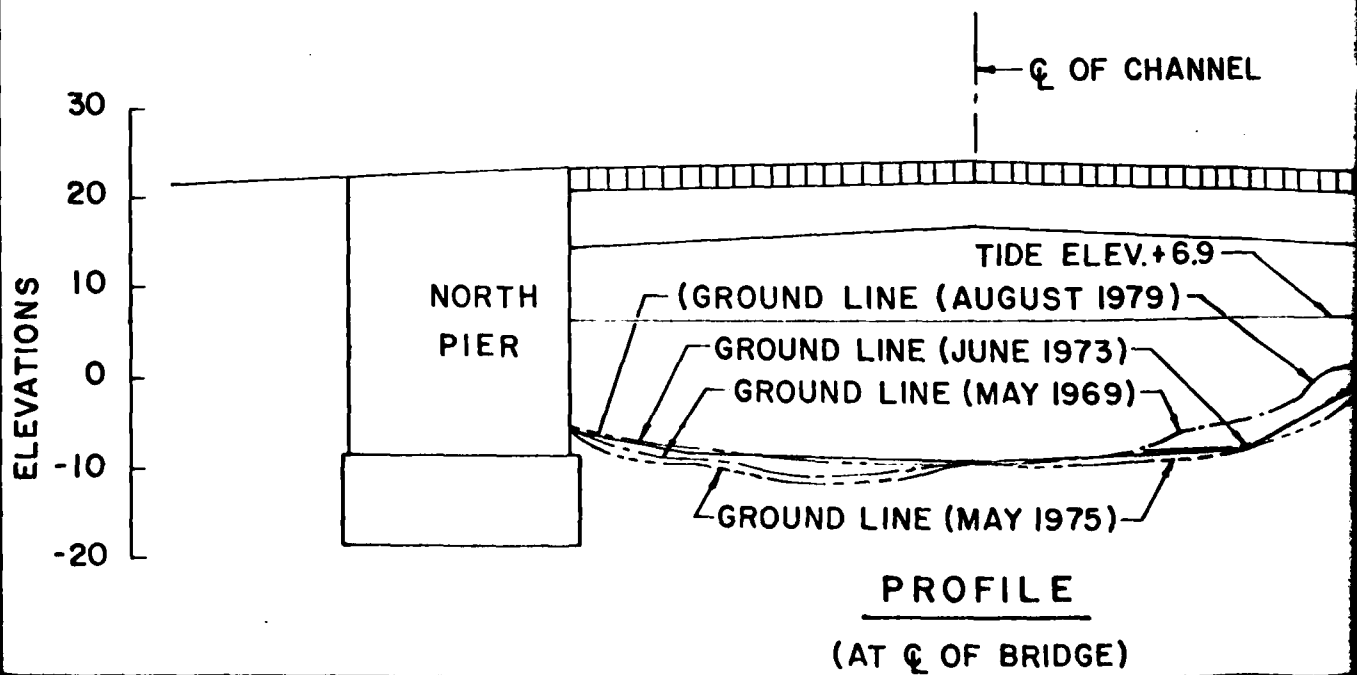
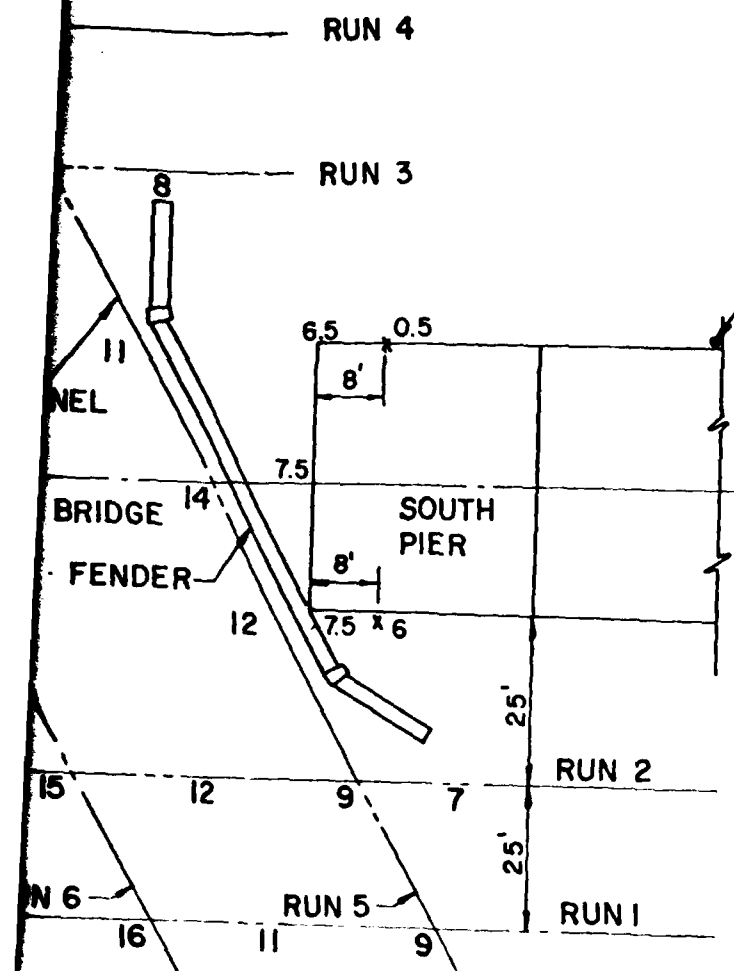
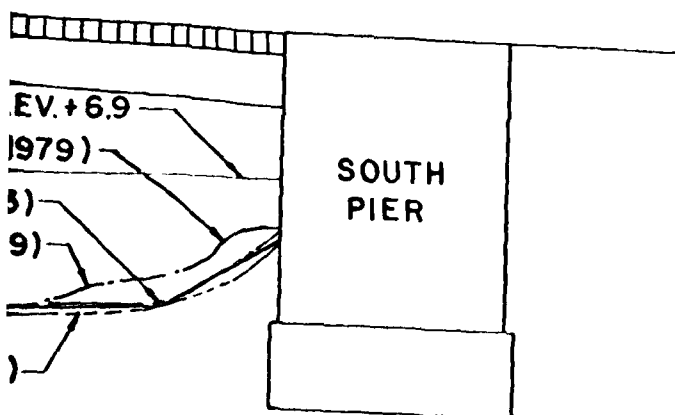
DRAWING 1-5

recorded on Drawing 1-5, appended. It can be observed that some silting has taken place around bank area.
